Mobile Intel® Celeron® Processor (0.18μ and 0.13μ)

Specification Update

March 2006

Document Number: 245421-048

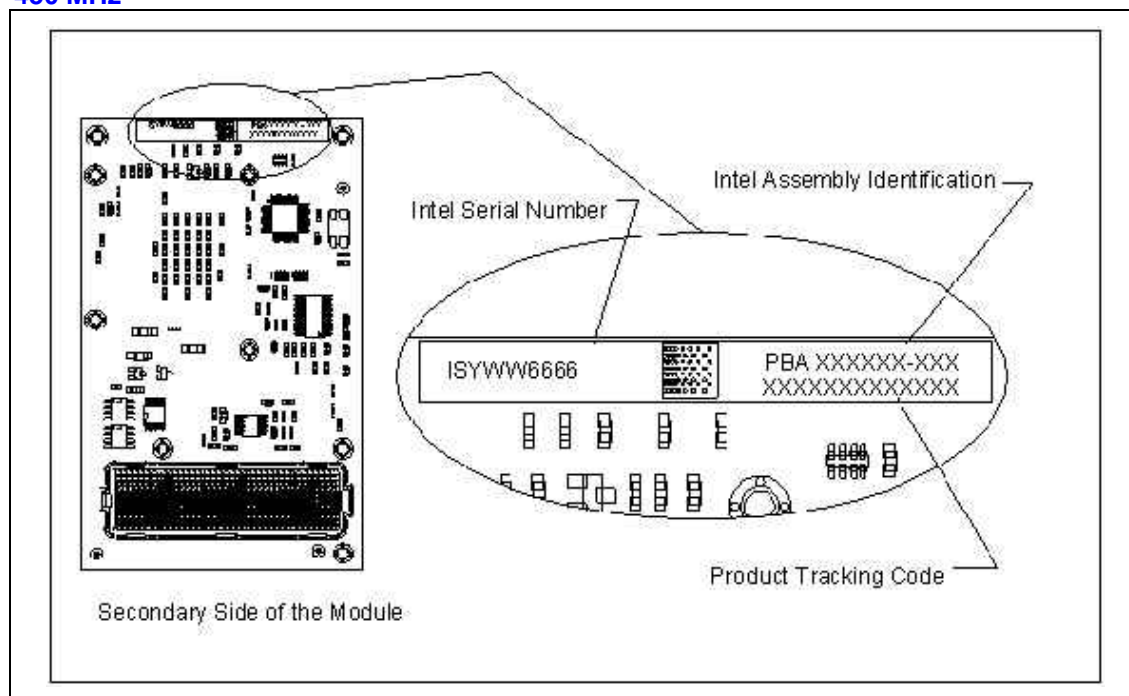
Figure 7. Intel® Celeron® Processor Mobile Module at 650 MHz, 600 MHz, 550 MHz, 500 MHz and 450 MHz

The Product Tracking Code (PTC) determines the Intel assembly level of the module. The PTC is on the secondary side of the module and provides the following information:

The PTC will consist of 13 characters as identified in the above example and can be broken down as follows:
